**FINAL REPORT**

# 2016-2019 Environmental Cleanup Grants Report for **FORMER McCLUNG WAREHOUSES and SANITARY LAUNDRY PROPERTIES**

### *Implementation of Environmental Cleanup Completed at Former Sanitary Laundry and McClung Warehouses Properties*

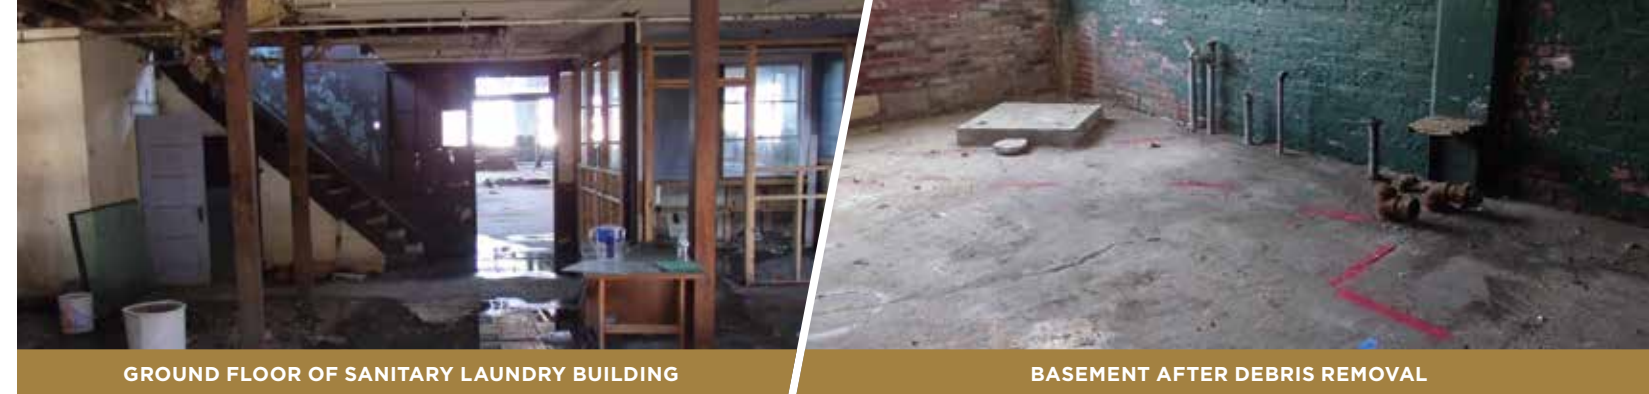
GROUND FLOOR OF SANITARY LAUNDRY BUILDING

BASEMENT AFTER DEBRIS REMOVAL

In January 2018, following the asbestos abatement, crews from the City removed and disposed of 21.26 tons (estimated 42,520 pounds) of solid waste previously stored in the basement of the Sanitary Laundry building. The material was removed by the City Solid Waste/Household Hazardous Waste Departments and processed through their waste disposal program. The material included pallets of paint, antifreeze, sealants, etc., as well as various building materials stockpiled in the basement.

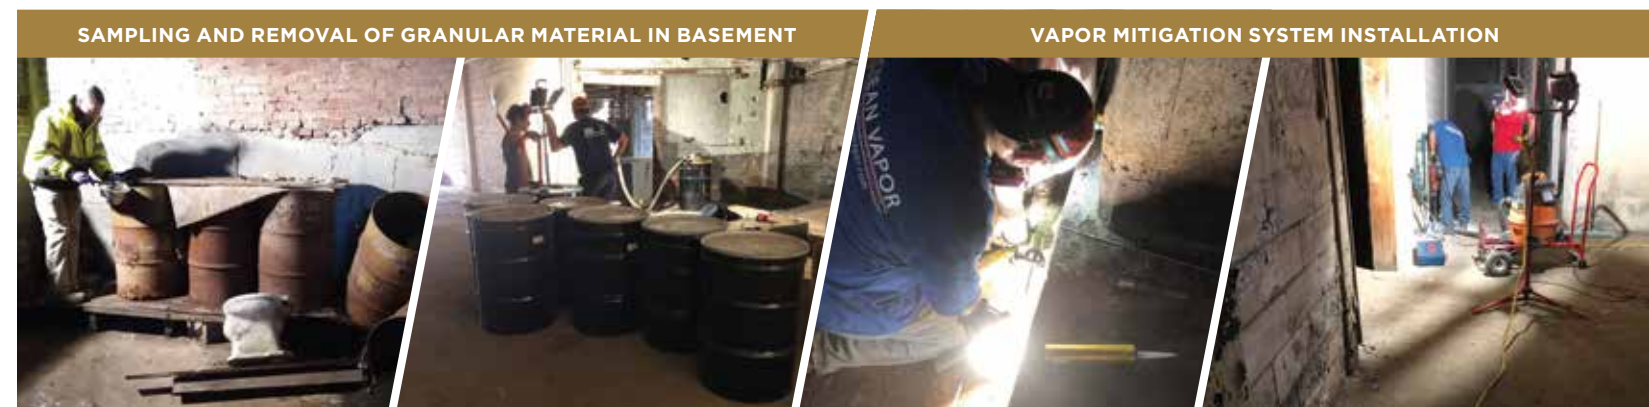
SAMPLING AND REMOVAL OF GRANULAR MATERIAL IN BASEMENT

VAPOR MITIGATION SYSTEM INSTALLATION

A total of six drums containing black granular material were formerly located in the basement, and these were removed for disposal in August 2019. Metals and low-level polynuclear aromatic hydrocarbons (PAHs) were detected in samples collected to characterize the material. A portion of the surfaces of the drums containing the material exhibited evidence of corrosion and deterioration due to rust which prevented the full waste-containing drums from being placed in overpack drums for disposal. S&ME subcontracted with Environmental Remediation Consultants, Inc. (ERC) to remove the material from the rusted drums and dispose of the granular material and the rusted drums. ERC classified the material as unused absorbents. The granular material was removed from the rusted drums using a drum vacuum. A total of eight new drums were utilized to containerize the granular material. The drums were transported under manifest as non-hazardous material to a permitted disposal facility.

Due to the potential for vapor intrusion-related health risks to future occupants of the building as determined from previous vapor sampling, a large portion of the Grant funds were used for the evaluation, design and partial installation of a sub-slab vapor mitigation system. Designs and quotes were obtained from two vendors, and Clean Vapor LLC (Clean Vapor) was selected following the evaluation of both systems and vendors. During August 2019, Clean Vapor installed 16 risers and suction points in accordance with their design for the vapor mitigation system. Since cleanup funds were limited, and because the building is currently un-occupied and therefore more prone to vandalism and/or theft, partial installation of the system was performed, eliminating the above-

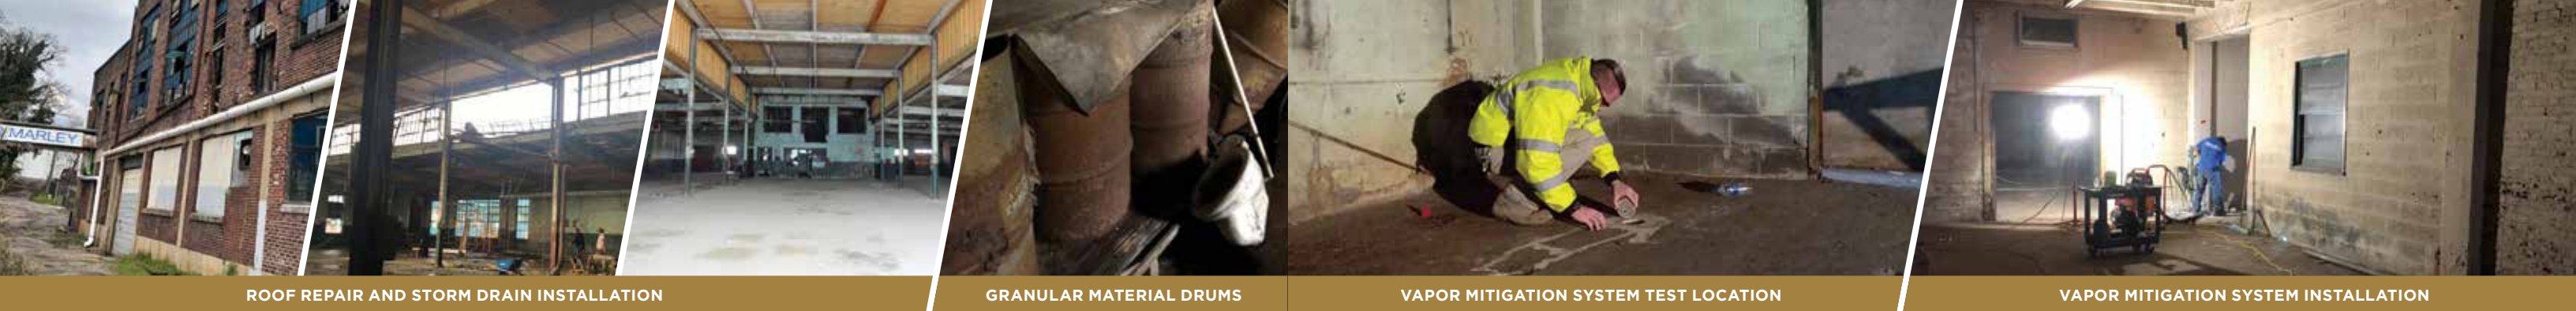
ROOF REPAIR AND STORM DRAIN INSTALLATION

GRANULAR MATERIAL DRUMS

VAPOR MITIGATION SYSTEM TEST LOCATION

VAPOR MITIGATION SYSTEM INSTALLATION

During the roof renovation performed by others, the roofing contractor removed portions of concrete slab comprising the basement floor in two locations and one location in the pavement outside of the building to accommodate proposed installation of the roof drains. Upon learning of this activity, the City instructed the contractor to stop sub-slab excavations and contacted S&ME, and an alternative approach for the roof drain installations was established. This activity was handled outside of the Grant, with the exception of the drum sampling performed in January 2018 to characterize the soil excavated by the roofing contractor and placed into three 55-gallon steel drums by S&ME to appropriately manage the material. The waste characterization soil samples detected volatile organic compounds (VOCs) consistent with the previous site characterization activities. The three drums were removed for proper disposal as special waste by Domermuth Environmental Services, located Knoxville, Tennessee.

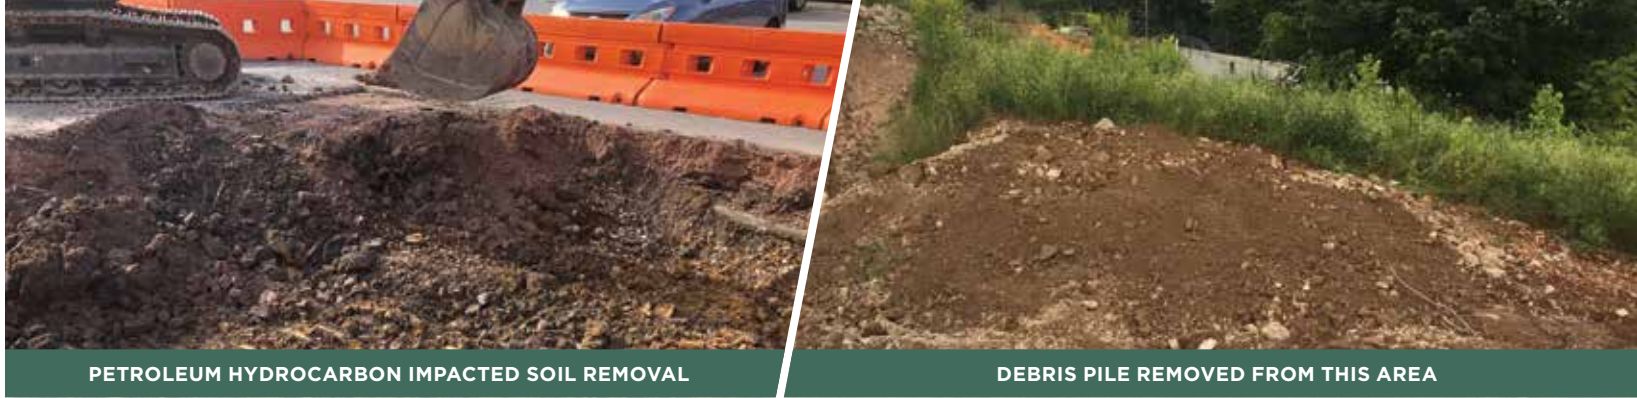
PETROLEUM HYDROCARBON IMPACTED SOIL REMOVAL

DEBRIS PILE REMOVED FROM THIS AREA

A total of 131 tons of petroleum hydrocarbon-impacted soil was excavated from the eastern portion of the site and transported to Domermuth Environmental Services for interim bioremediation prior to disposing in a Class I Subtitle D landfill. The excavation was then backfilled with rock, and the area was repaved by the City.

In addition to the soil excavation mentioned above, 258 cubic yards of ACM and LBP impacted demolition debris was removed from the site and transported to Chestnut Ridge Landfill for disposal. Approximately 500 cubic yards of demolition debris containing ACM and LBP remain on the site with an additional 200 cubic yards ramped along Jackson Avenue. The debris is from the demolition of the former warehouse structures after fires in 2007 and 2014. Since the ACM cannot feasibly be segregated from these debris piles, they would be considered asbestos waste, and should be handled accordingly. Removal of the material ramped along Jackson Avenue is not recommended until site redevelopment is planned.

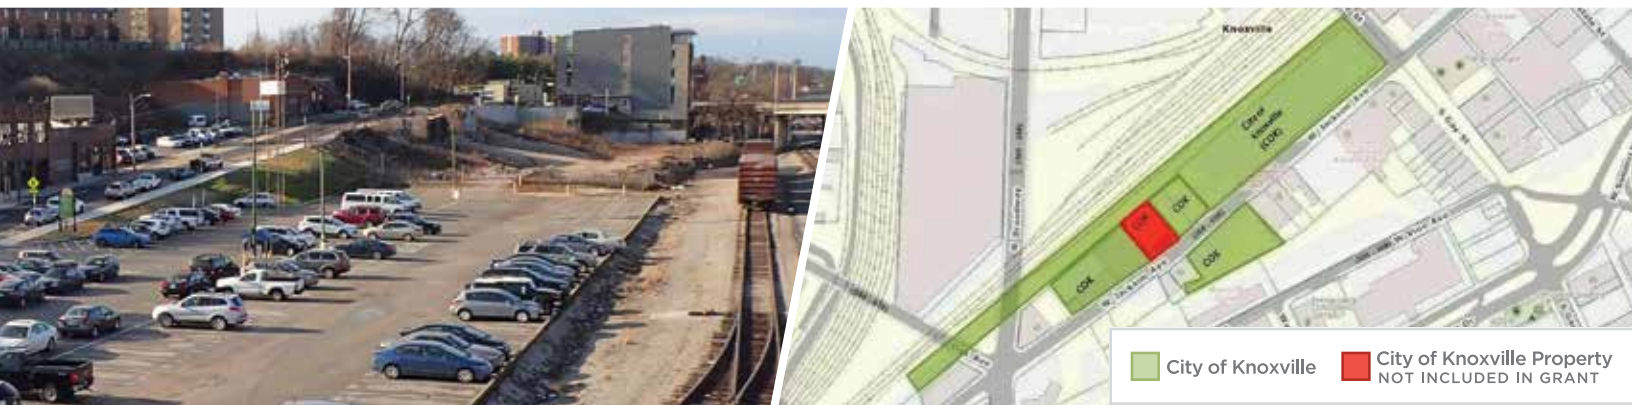
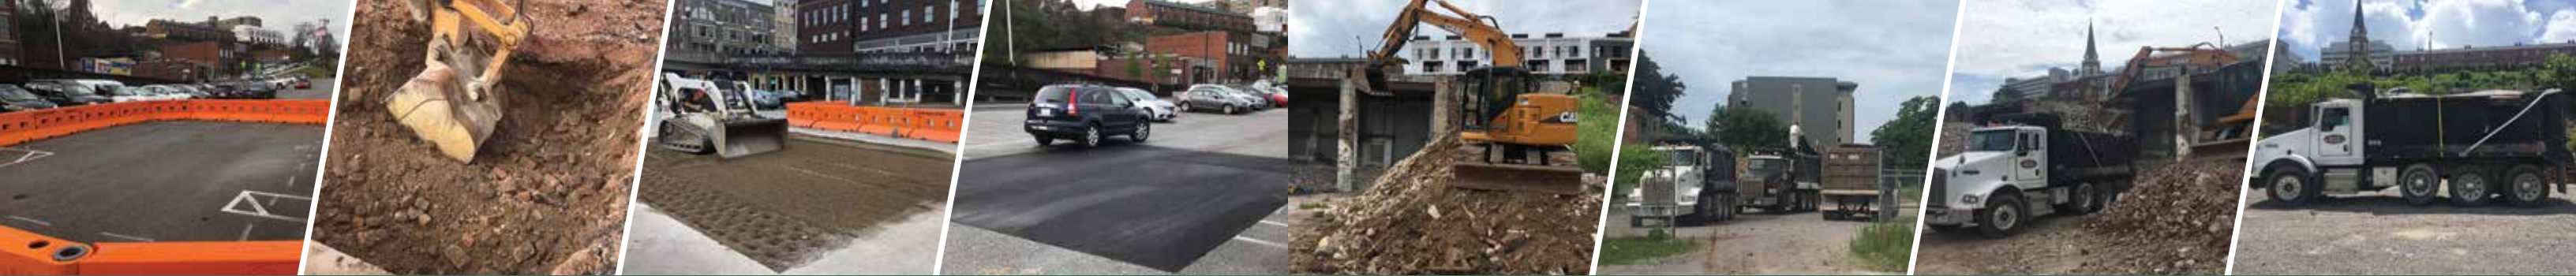
BEFORE, DURING AND AFTER THE REMOVAL OF PETROLEUM HYDROCARBON-IMPACTED SOIL AT THE McCLUNG WAREHOUSES SITE

REMOVAL OF DEMOLITION DEBRIS AT THE McCLUNG WAREHOUSE SITE

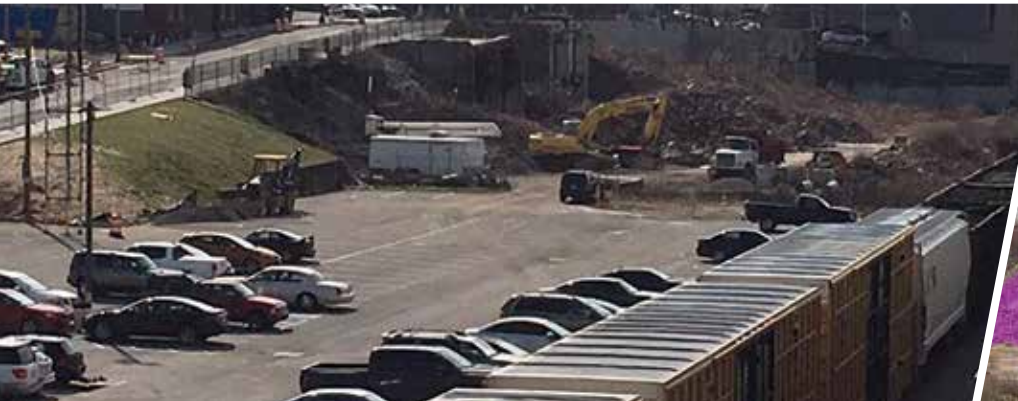
DEBRIS PILE VOLUME ESTIMATES

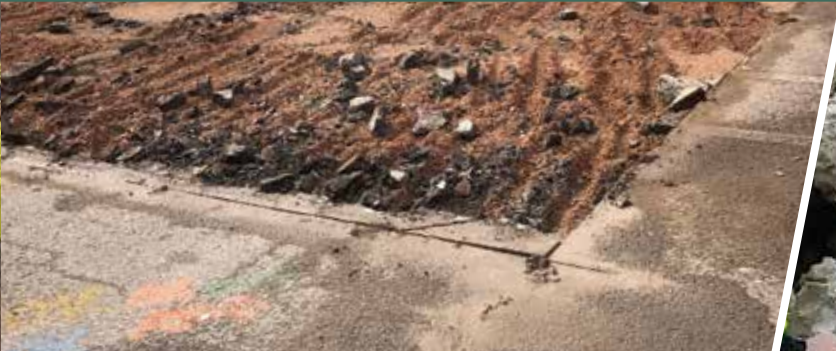
DEBRIS PILE AT FORMER WAREHOUSE

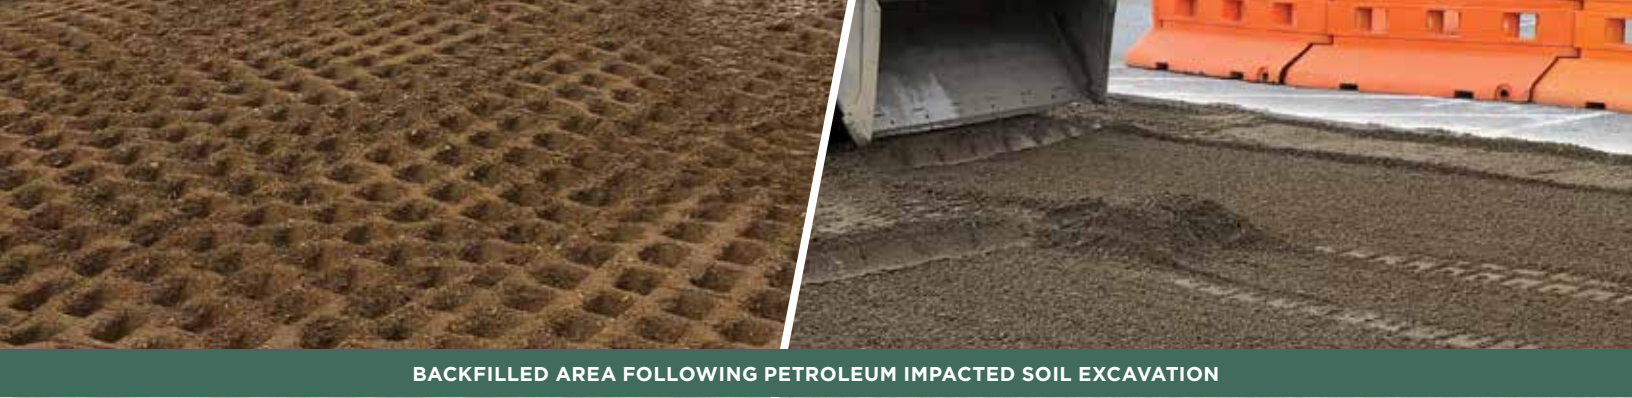
BACKFILLED AREA FOLLOWING PETROLEUM IMPACTED SOIL EXCAVATION
